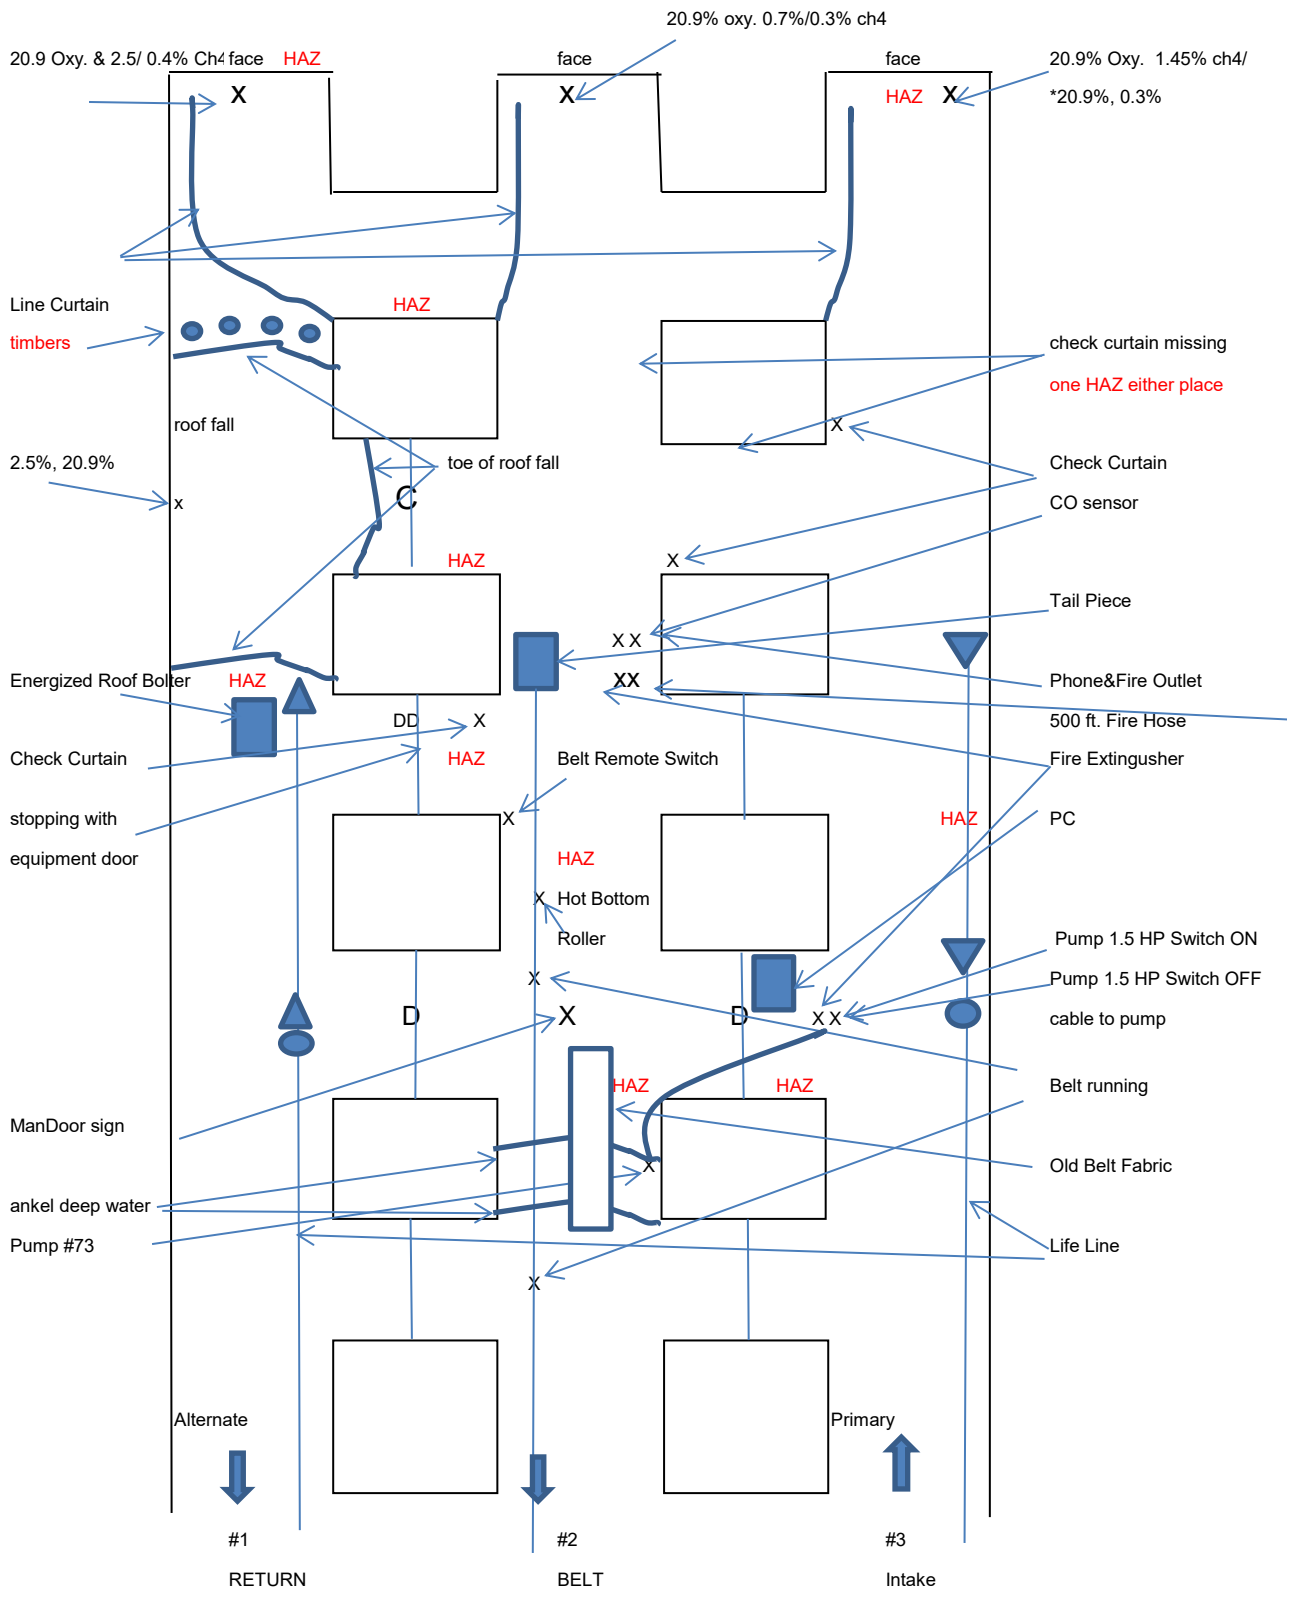
20.9% oxy. 0.7%/0.3% ch4
20.9 Oxy. & 2.5/ 0.4% Ch4 face
HAZ
face
face
20.9% Oxy. 1.45% ch4/
*20.9%, 0.3%
HAZ
Line Curtain
timbers
HAZ
check curtain missing
one HAZ either place
roof fall
2.5%, 20.9%
toe of roof fall
Check Curtain
CO sensor
HAZ
Tail Piece
Energized Roof Bolter
HAZ
Phone&Fire Outlet
500 ft. Fire Hose
Check Curtain
HAZ
Belt Remote Switch
Fire Extingusher
stopping with
equipment door
HAZ
PC
HAZ
Hot Bottom
Roller
Pump 1.5 HP Switch ON
Pump 1.5 HP Switch OFF
cable to pump
Belt running
HAZ
HAZ
ManDoor sign
Old Belt Fabric
ankel deep water
Pump #73
Life Line
Alternate
Primary
#1
RETURN
#2
BELT
#3
Intake
